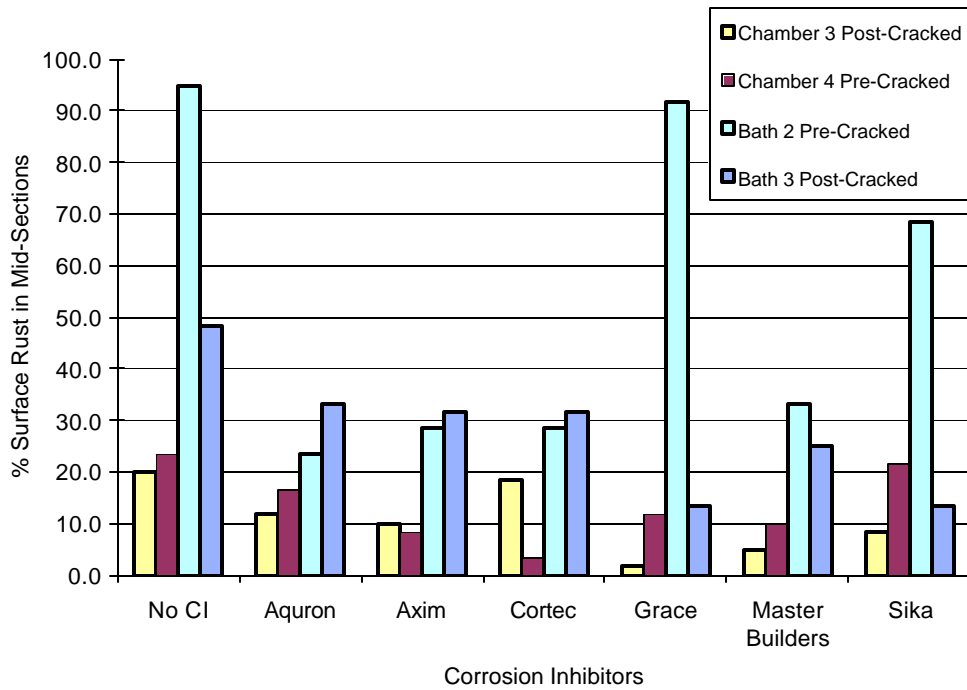
Figure E.15 Surface Corrosion at Mid Section for 0.0% Chloride (Set#2)

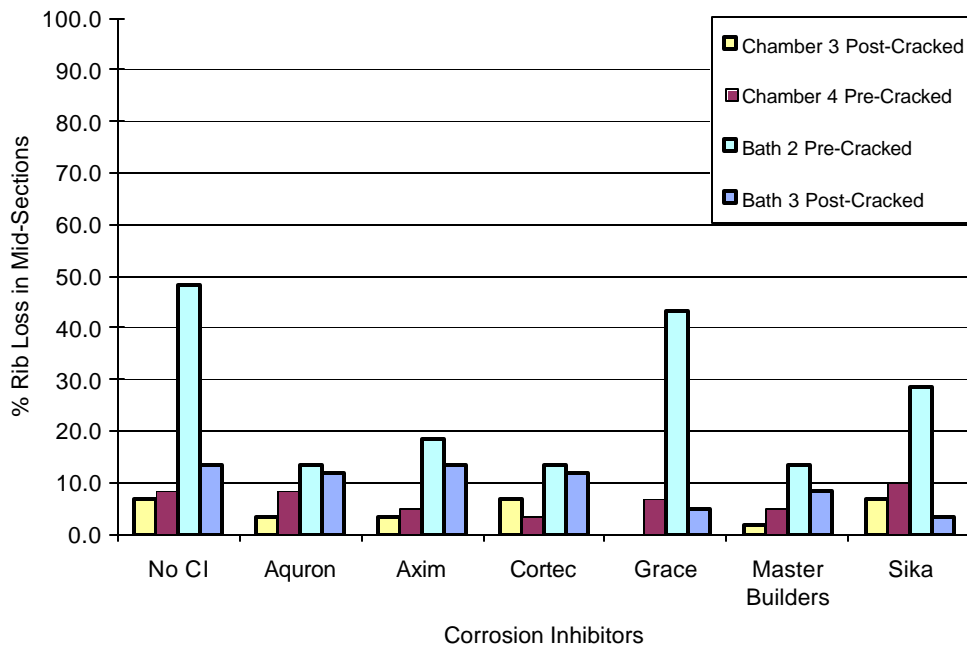
Figure E.16 Rib Loss at Mid Section for 0.0% Chloride (Set #2)
